2024 Pedestrian Bridge Inspections Waterloo Firemen's Park

CORRE, Inc. (CORRE) has completed a routine, visual inspection of the two (2) pedestrian bridges in Firemen's Park over the Maunesha River. The following is a summary of the inspection findings, photographs taken during the inspection, and maintenance recommendations for each structure.

#1 - WEST PEDESTRIAN BRIDGE (NEAR PARK AVE ENTRANCE)

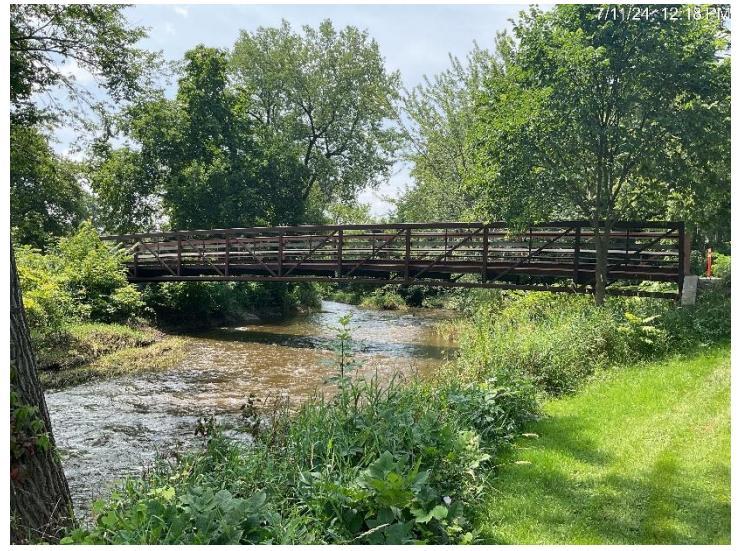
East elevation view

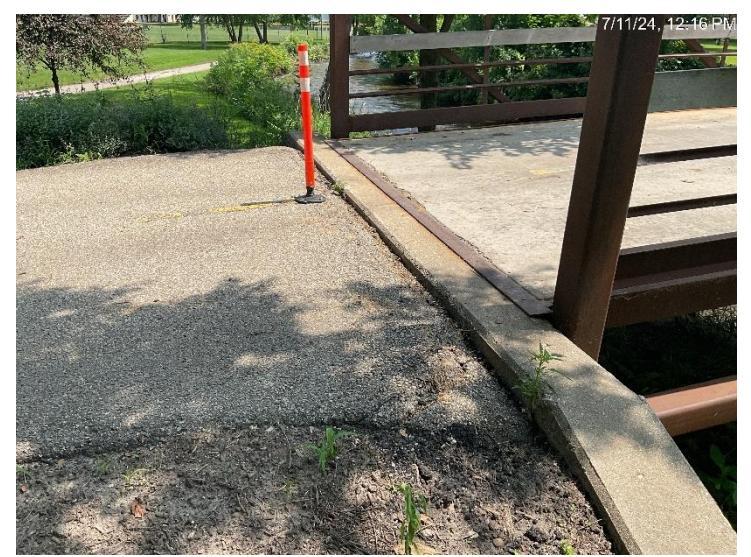
- **Approach Path:** Both ends are settled at the bridge up to 1.5", with the worst settlement being at the North end. The joints at each end are unsealed and open, allowing water to leak down to the abutment and affect the steel floor beams, abutment concrete, and concrete overlay.

North approach pavement settlement

- Approach Pavement and Joints High: Approach pavement should be wedged or resurfaced to match bridge's walking surface elevation. The open joints at each end should be sealed with a flexible, pourable joint sealant to prevent water leakage through joint.

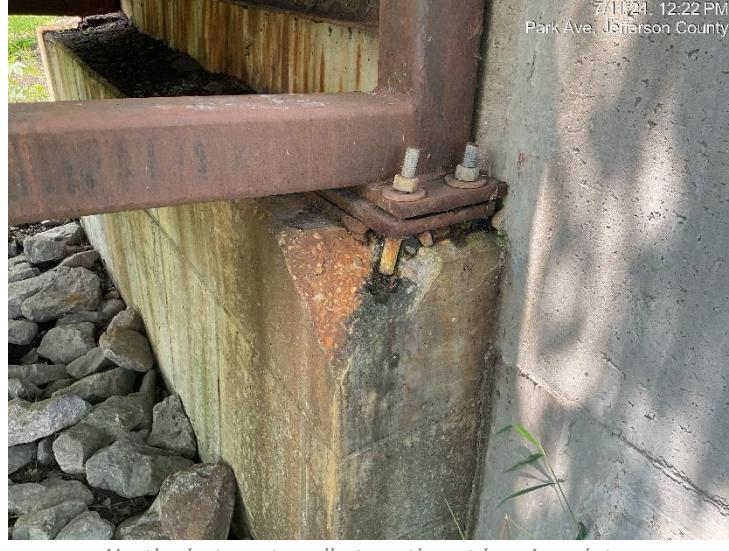
- **Reinforced Concrete Abutments:** Both abutments have rust staining from leaking through the open joints above. The North abutment has spalled concrete at the top corner beneath the northwest bearing pad exposing the anchor bolt. The South abutment exhibited no other defects.

North abutment spall at northeast bearing plate

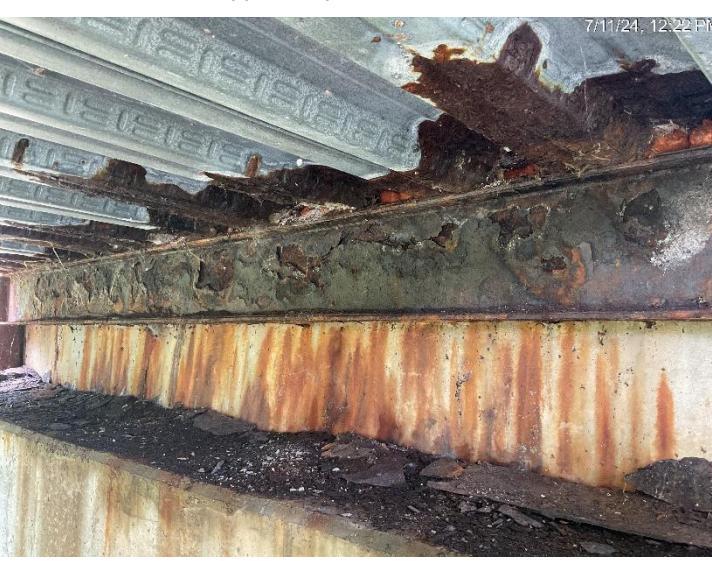
- **Steel Truss Superstructure:** The truss is in relatively good condition with exceptions at the Northern-most and Southern-most transverse floor beams. Each of these floor beams exhibits severe corrosion and section loss due to water leakage from the open joints. Both floor beams have sections with full section loss holes due to the corrosion.

Severe corrosion at north floor beam

- **Repair Corroded Floor Beams High:** The end floor beams at each abutment should be removed and replaced. After replacement, the last 10' of the steel truss lower cord and floor beams should be painted to preserve the self-weathering steel.

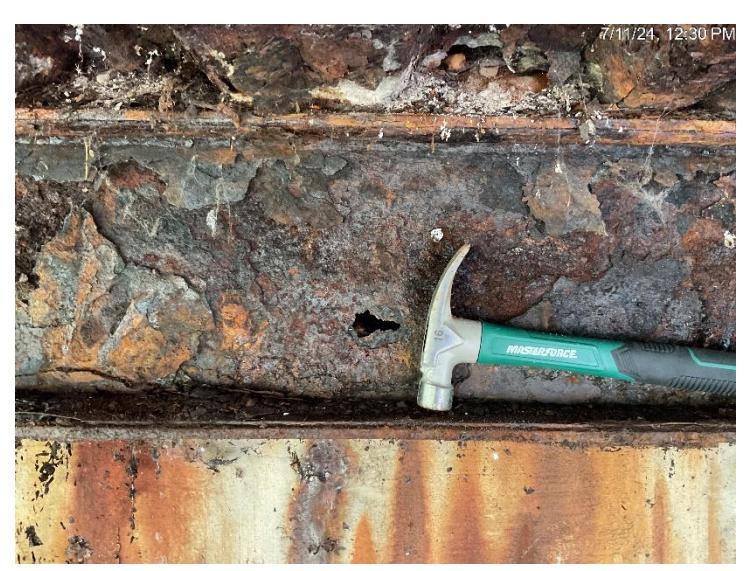
Section loss and corrosion at North floor beam

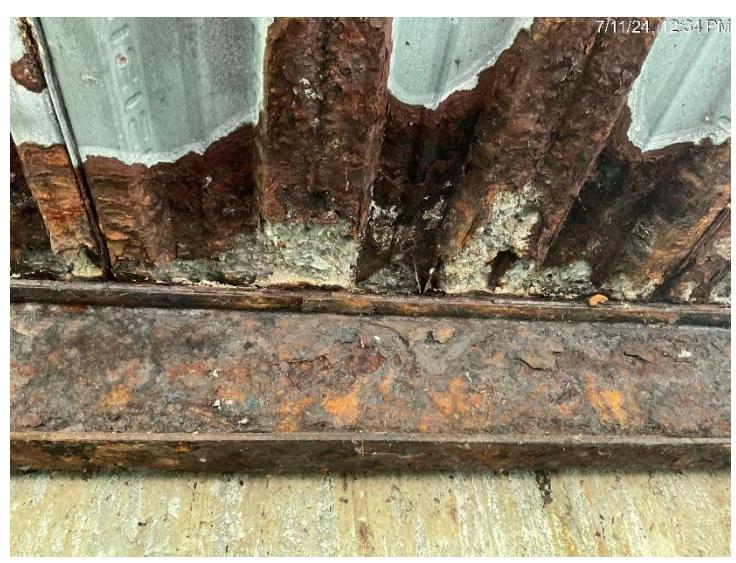
- **Concrete Overlay:** The overlay is in good condition along the top surface, but fair condition beneath near the abutments. There is some insignificant cracking in the surface, but no other defects were noted. The galvanized stay-in-place (SIP) forms below have moderate to severe corrosion at both abutments as well as each construction joint in the concrete overlay. This corrosion is due to water leakage through the joints and de-icing efforts. Corroded portions at the abutments have areas of full section loss in the forms, and also exhibits concrete which has spalled off and exposed the reinforcing steel.

Concrete spall/exposed reinforcing steel at North SIP forms

- **Repair Galvanized Stay-in-Place Forms High:** While the floor beams are removed for repair, the SIP forms with corrosion should be cleaned and painted with a galvanizing paint. The areas of exposed concrete and reinforcing steel should be repaired. Exposed reinforcing steel should be cleaned and painted with a 2-part epoxy paint and the concrete should be repaired with a surface repair material.

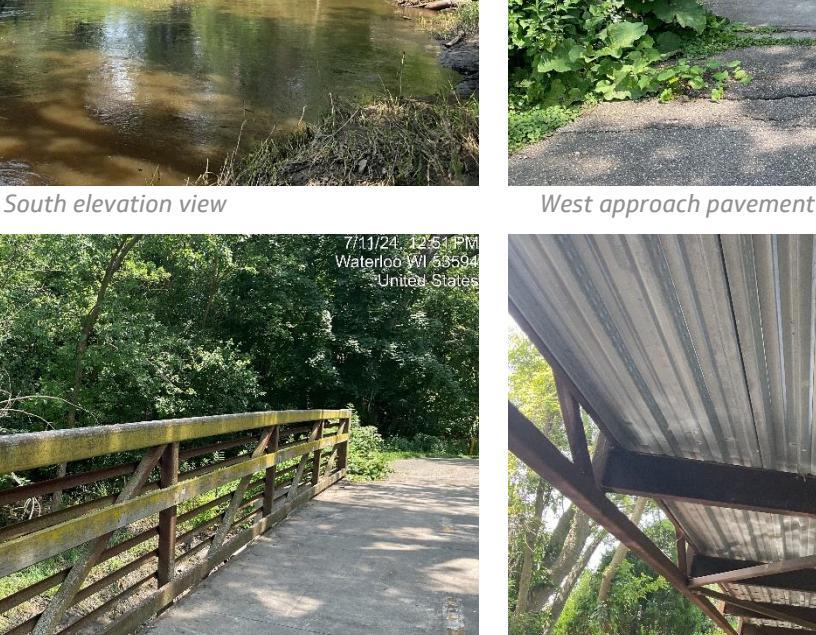
- **Bridge Rails:** The steel railings and wooden rub rail have algae growth throughout, but no other noted defects.
- **Reinforced Concrete Abutments:** Both abutments are in good condition. The West abutment, northwest corner, has a small section with minor map cracking that is delaminated but has not spalled off.

- **Steel Truss Superstructure:** The truss is in good condition and has algae growth throughout, but no other defects were noted.

Typical algae growth on rails and truss

- Clean Truss and Rails Low: The algae growth throughout the structure should be cleaned or powerwashed off to limit moisture being trapped against the steel which can lead to corrosion and deterioration of the self-weathering steel members.
- **Approaches and Joints Medium:** Spray vegetation and brush to remove/kill growth from approaches, pavement joints and surrounding abutment/wing walls.

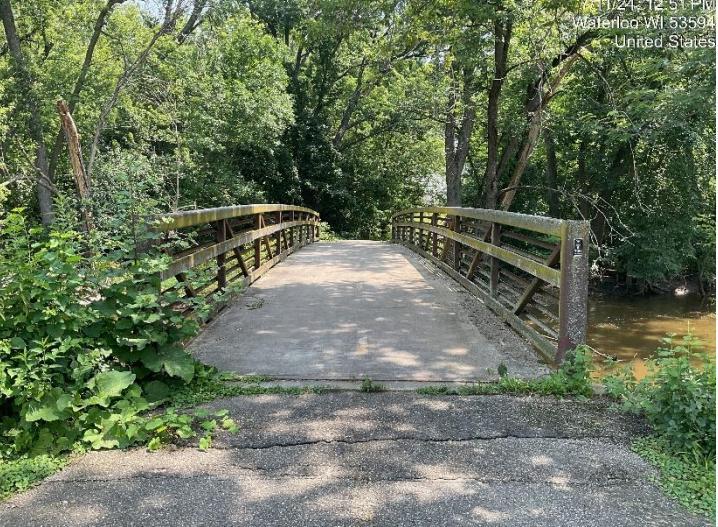
- **Approach Path:** Both ends are settled at the bridge up to 3/4" and have previously been wedged with additional asphalt. The joints at each end are unsealed and open, allowing water to leak down to the abutment and potentially affect the steel floor beams, abutment concrete, and concrete overlay.

West approach pavement and longitudinal view looking East

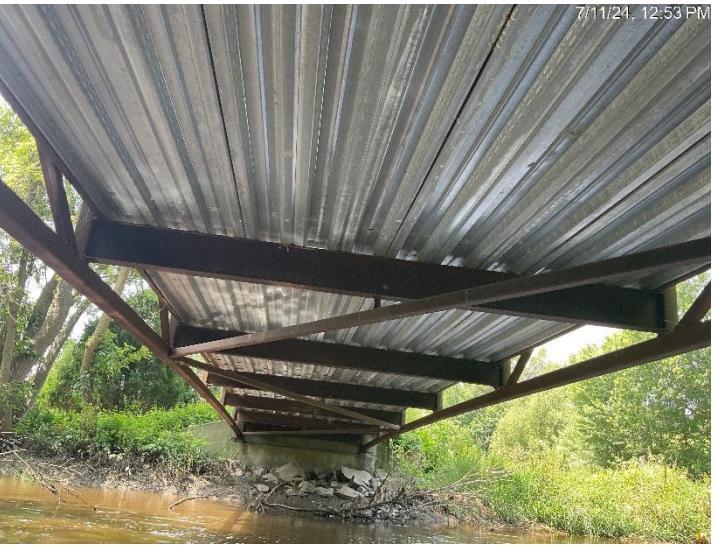
Typical view of SIP and truss lower cord

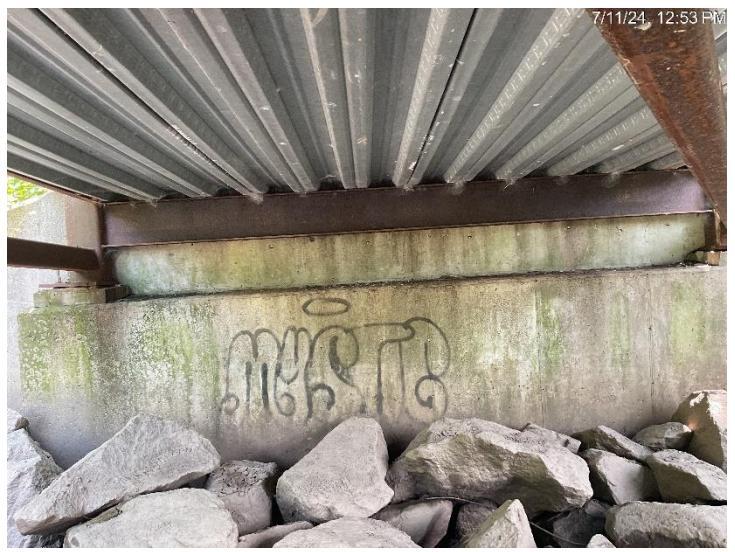
West abutment and floor beam typical condition

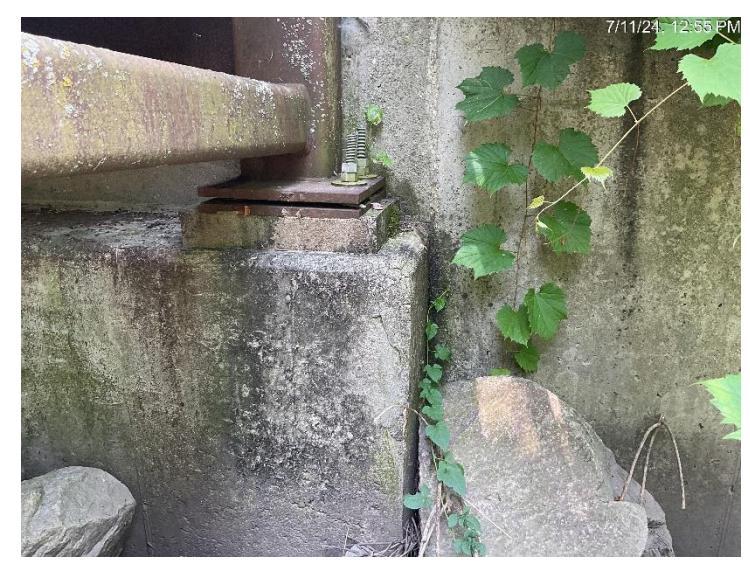
Minor map cracks at West abutment, North bearing
