2024 Pedestrian Bridge Inspections Waterloo Firemen's Park

CORRE, Inc. (CORRE) has completed a routine, visual inspection of the two (2) pedestrian bridges in Firemen's Park over the Maunesha River. The following is a summary of the inspection findings, photographs taken during the inspection, and maintenance recommendations for each structure.

#1 - WEST PEDESTRIAN BRIDGE (NEAR PARK AVE ENTRANCE)

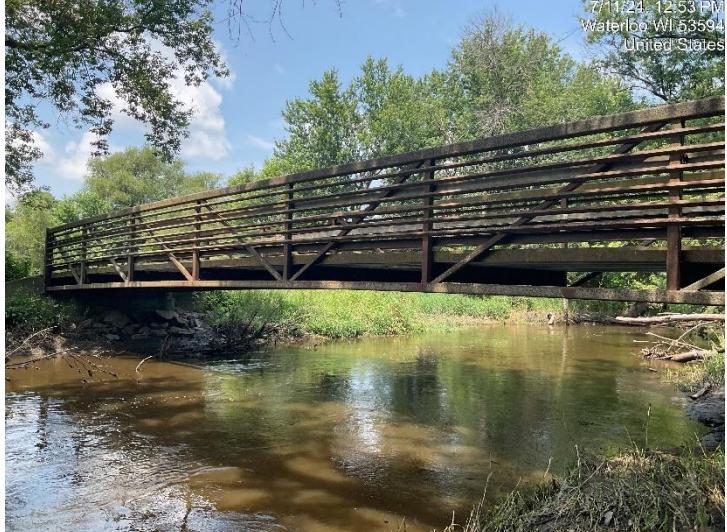
- **Steel Truss Superstructure:** The truss is in good condition and has algae growth throughout, but no other defects were noted.

Typical algae growth on rails and truss

- Clean Truss and Rails Low: The algae growth throughout the structure should be cleaned or powerwashed off to limit moisture being trapped against the steel which can lead to corrosion and deterioration of the self-weathering steel members.
- **Approaches and Joints Medium:** Spray vegetation and brush to remove/kill growth from approaches, pavement joints and surrounding abutment/wing walls.
